MISCELLANEOUS PAPER GL-85-21

CRATER REPAIR OF NORTH AUXILIARY AIRFIELD, SOUTH CAROLINA

August 1985

Final Report

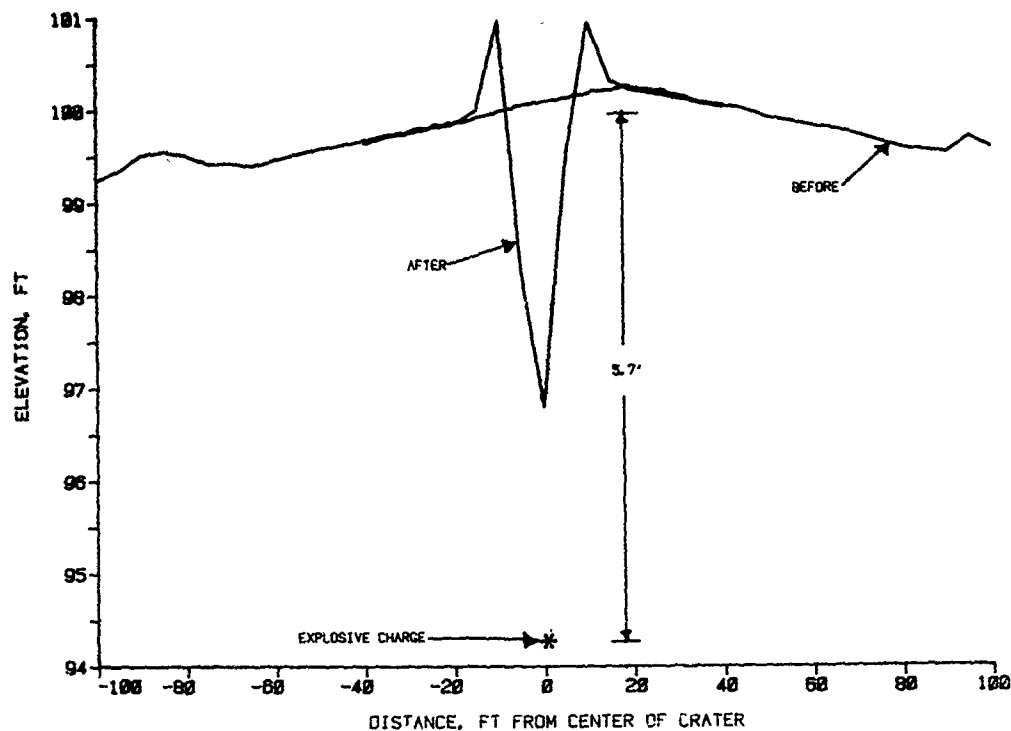
Figure 1. Runway surface cross section before and after the west crater was exploded in a north-south direction (across runway), also depth at which charge was placed, precast slab repair

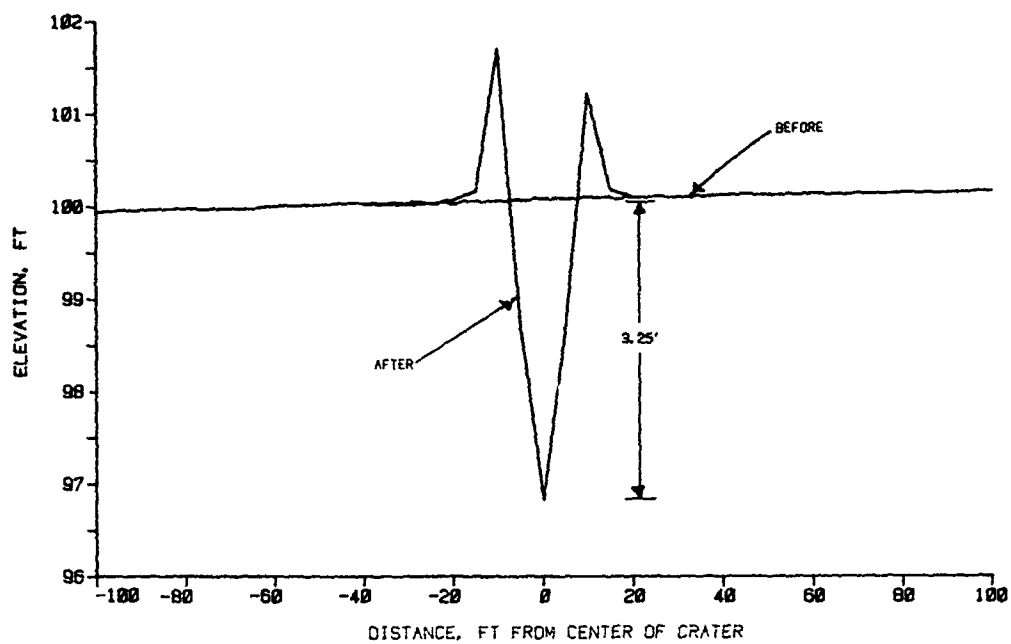
Figure 2. Runway surface before and after the west crater was exploded in a west-east direction (direction of traffic), precast slab repair

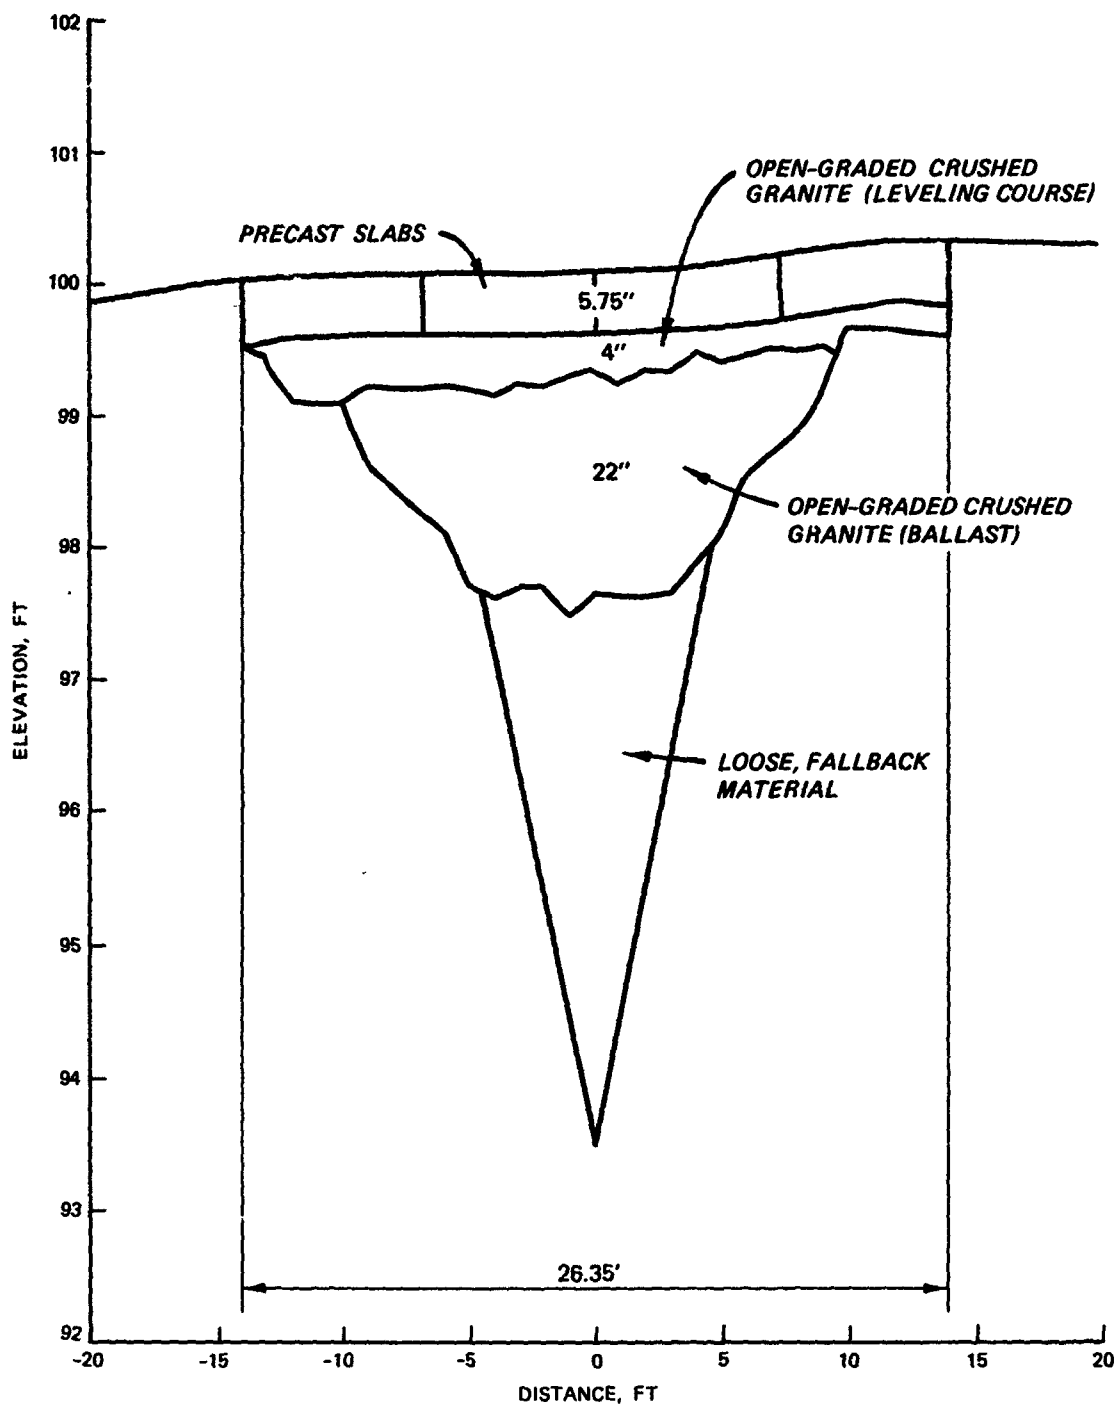
Figure 4. Thickness of materials used in the precast slab repair, north-south direction

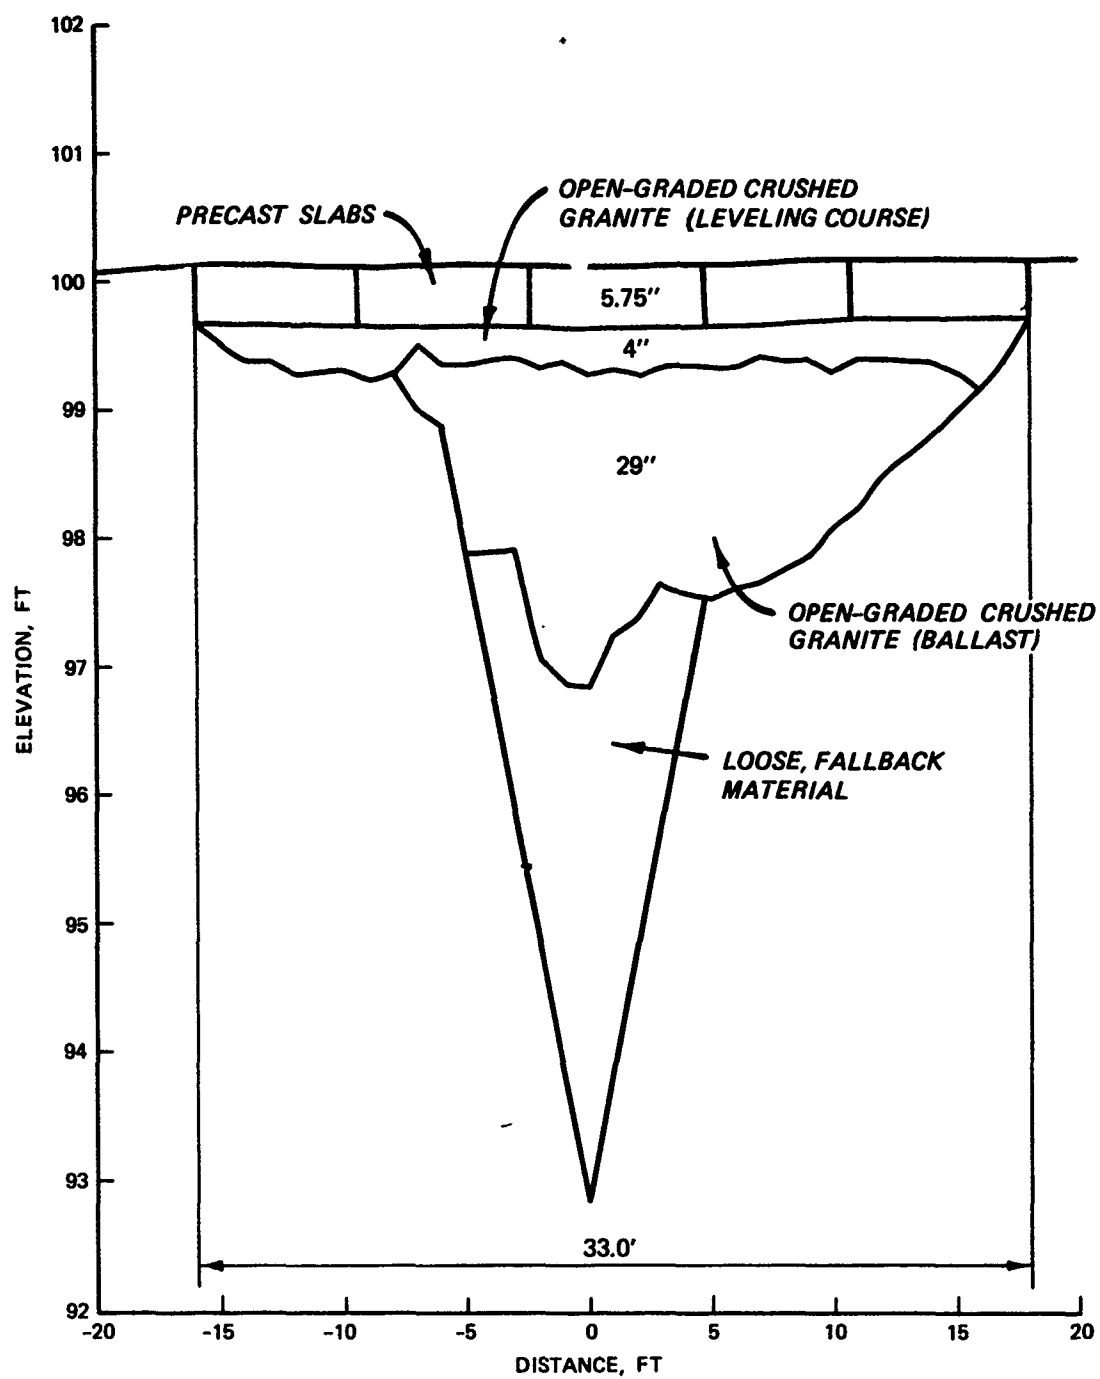
Figure 5. Thickness of materials used in the precast slab repair, west-east direction

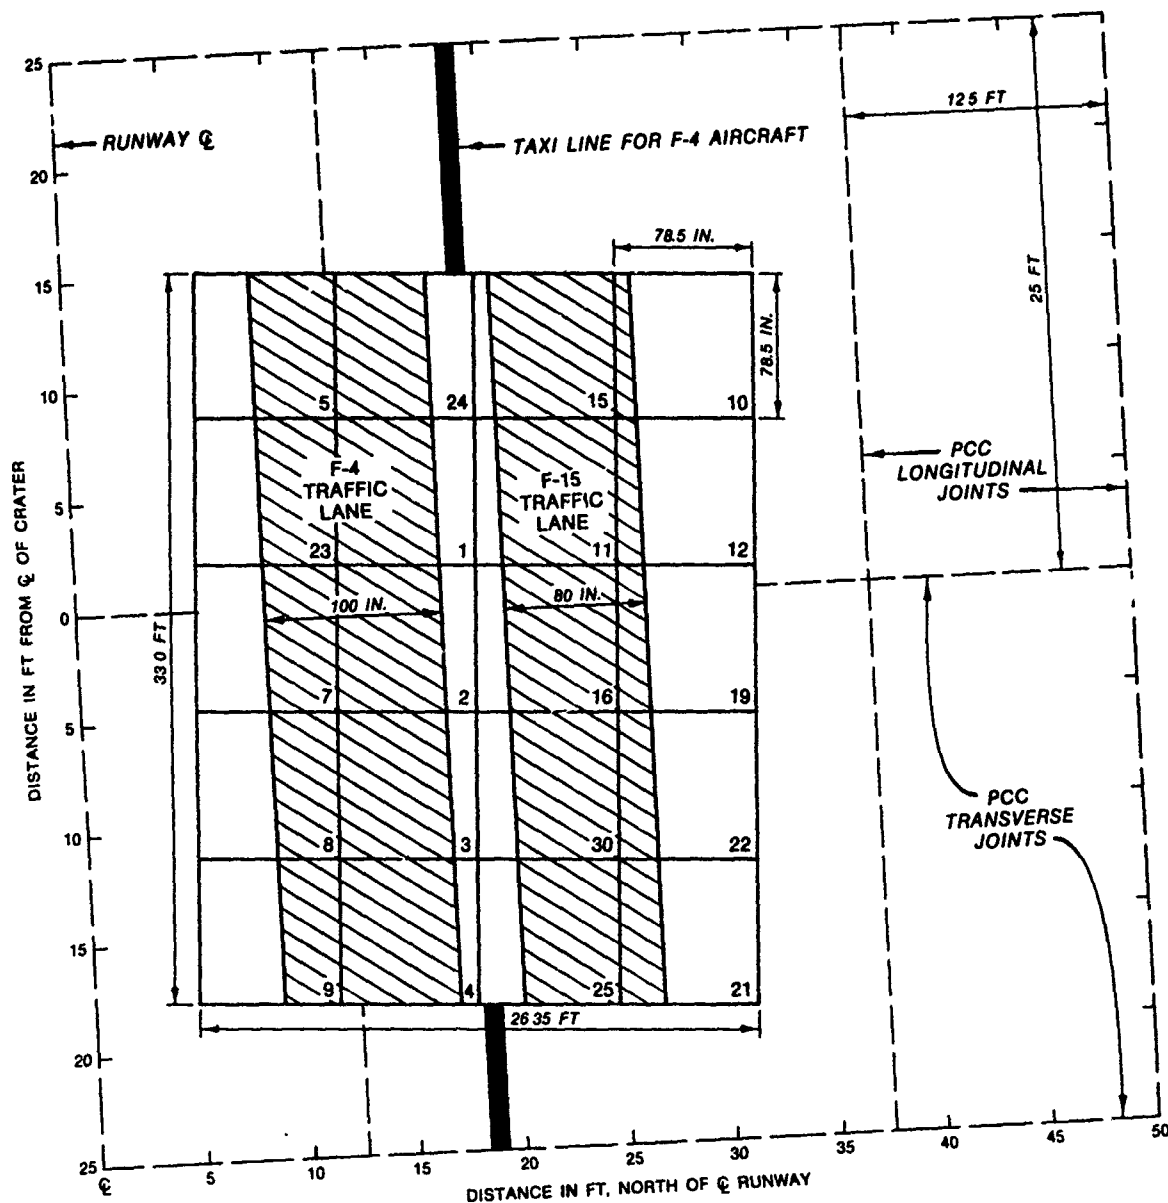
Figure 13. Layout of precast slab repair

18. A layout of the crater repair is shown in Figure 13. Note that each slab is numbered. Slabs were numbered for identification of defects prior to placement; therefore, there is no order to the numbers on the slabs after placement. These defects are shown in Table 3. Photo 25 shows the crater repair prior to traffic. Surface roughness measurements taken before traffic are given in Table 4. The maximum sag measured was 0.5 in. Proof loading of the repair with the F-4 load cart was accomplished by driving the load cart across the crater repair with the load wheel located along the outside edge of the slabs in the outside (north) row of slabs. The load cart wheel was driven forward and backward in the same path. The load wheel was then shifted to the other (inside) edge on the same row of slabs and driven forward and backward in the same path and then shifted over to the next edge. This was repeated until each edge on each row had been proof loaded. After each edge had been loaded, the cart was driven with the load wheel passing forward and backward down the center of the slabs in each row. Considerable movement of the slabs was observed during the proof-testing of the crater repair. The most movement occurred when the load wheel was on the corner of a slab. There were no measurements taken during this initial proof loading; however, some of the slabs tipped at least 6 in. because the bottom edge of the slab could be seen

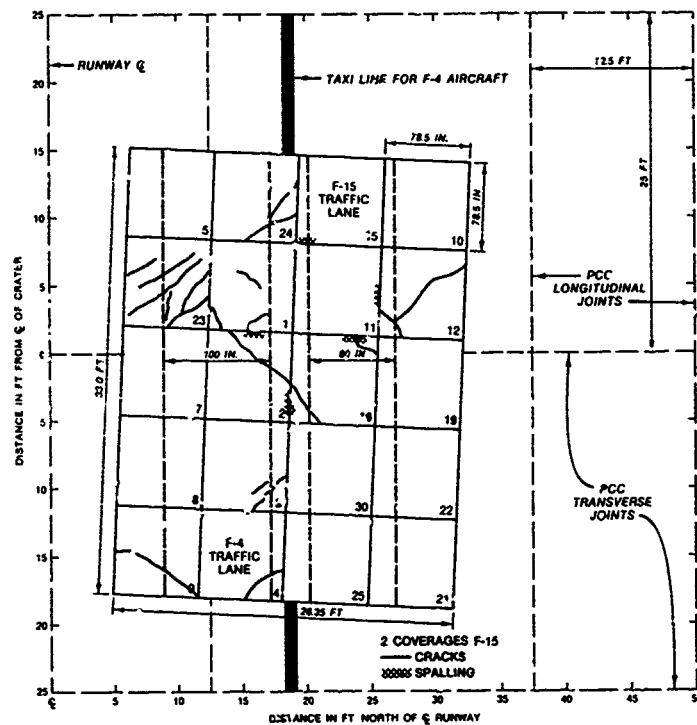
23. After the aircraft traffic was completed, the F-15 load cart traffic lane (80 in. wide) was laid out (Figure 13) and traffic was applied. After two coverages, the maximum sag measurement was 1.75 in. located on the joint line inside of the traffic lane. Figure 35 shows the increase in defects (spalling and cracks) in the slabs since run 15 of the aircraft. The defects in the south two rows of slabs were caused by the F-4 aircraft after run 15. Spalling is visible in Photo 29. The spalling is located on slabs 15 and 16. As the traffic continued to 10 coverages, eight of the ten slabs in the traffic lane contained breaks or cracks (Figure 36). At this time, there was an increase in the spalling on the slabs, especially on slabs 30, 16, and 11. This would present an FGD problem due to the size of the particles (Photo 30). The maximum sag measurement at 10 coverages was 2.50 in. (Table 4) without the load wheel on the repair and 3.00 in. (failure criteria) with the load wheel on the repair (Photo 30). Using the pass-to-coverage ratio, this 10 coverages would be equivalent to 94.6 F-15 operations. It should be noted that the crater repair received eight passes of the F-4 aircraft traffic after maintenance was performed. Counting all F-4 traffic since construction, 23 passes with the aircraft and two coverages with the F-4 load cart (equivalent to 17.2 aircraft operations) were applied. Figures 28 through 34 show profile data for the crater repair after the 10 coverages of the F-15 load cart compared to the data after aircraft traffic. After 14 coverages, the maximum

Figure 35. Defects in slabs after two coverages of F-15 traffic

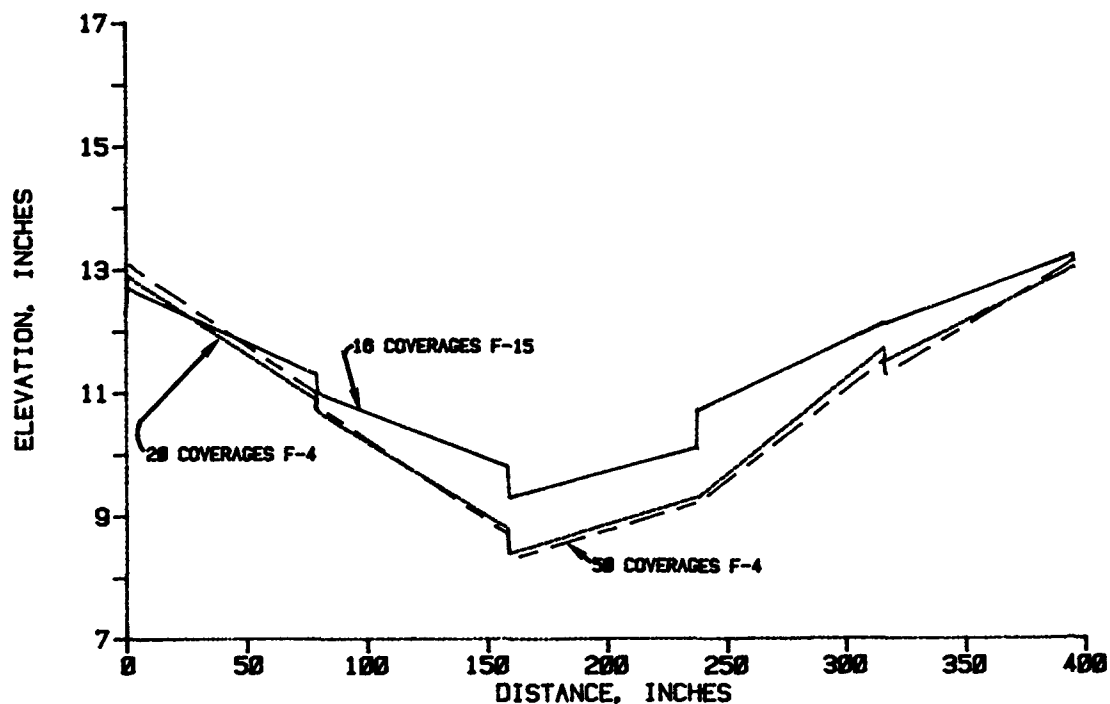
Figure 41. Line 7, profile, precast slab repair after F-4 traffic

the cracks in the original PCC east of the crater repair. Figure 49 shows the location of all the spalling in the crater repair. There were no breaks or cracks generated in any of the slabs by F-4 load cart traffic. Figures 41 through 46 show profile data (50 coverages) in comparison with data when F-4 load cart traffic was resumed and after 20 coverages.

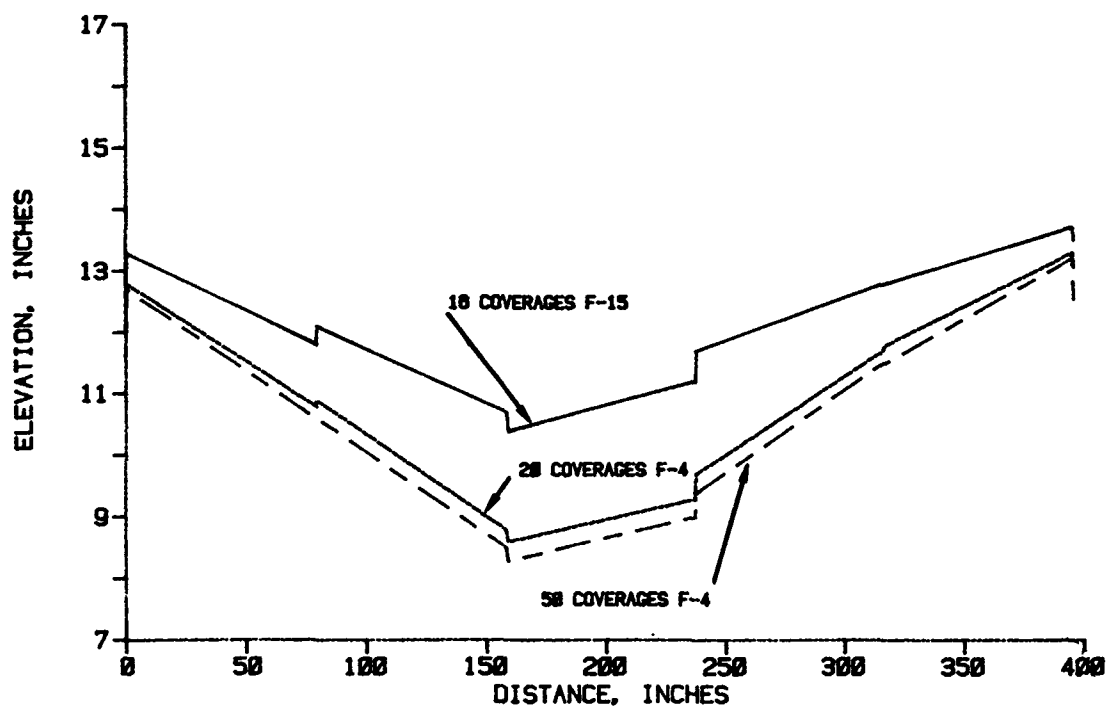
Figure 42. Line 8, profile, precast slab repair after F-4 traffic

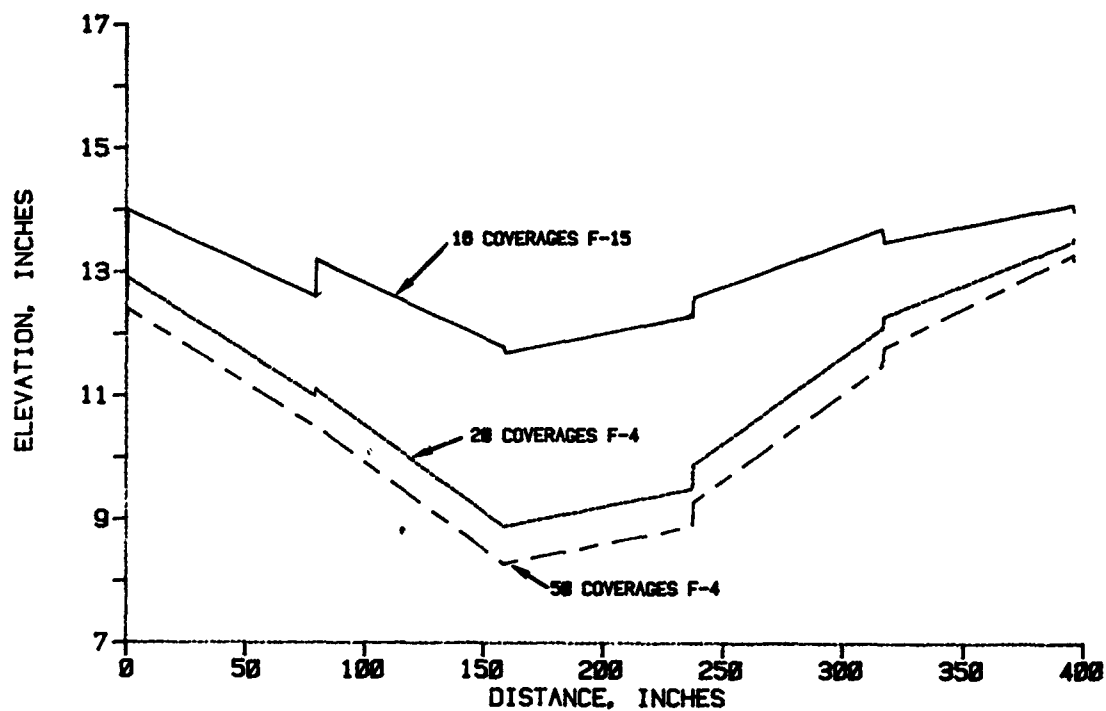
Figure 43. Line 9, profile, precast slab repair after F-4 traffic

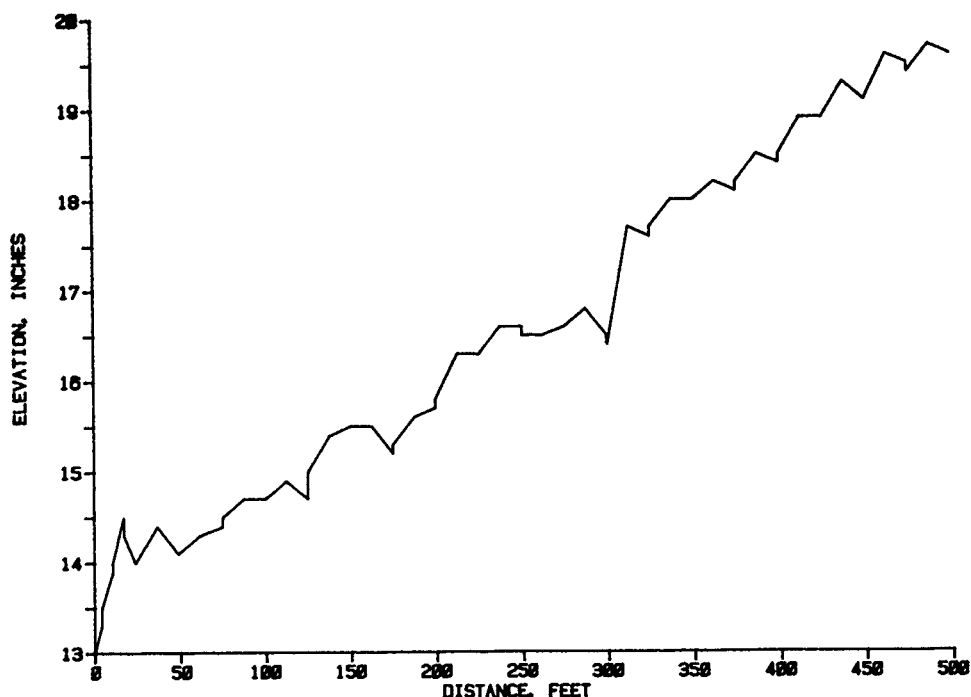
Figure 63. 500-ft lead-in profile, from the center of the crater east, south wheel path F-4 aircraft, precast slab repair

27. Figure 63 shows profile data taken from the center of the crater repair out 500 ft east. The profile data was taken before any traffic was applied to the center and was located along the south wheel path of the F-4 aircraft.

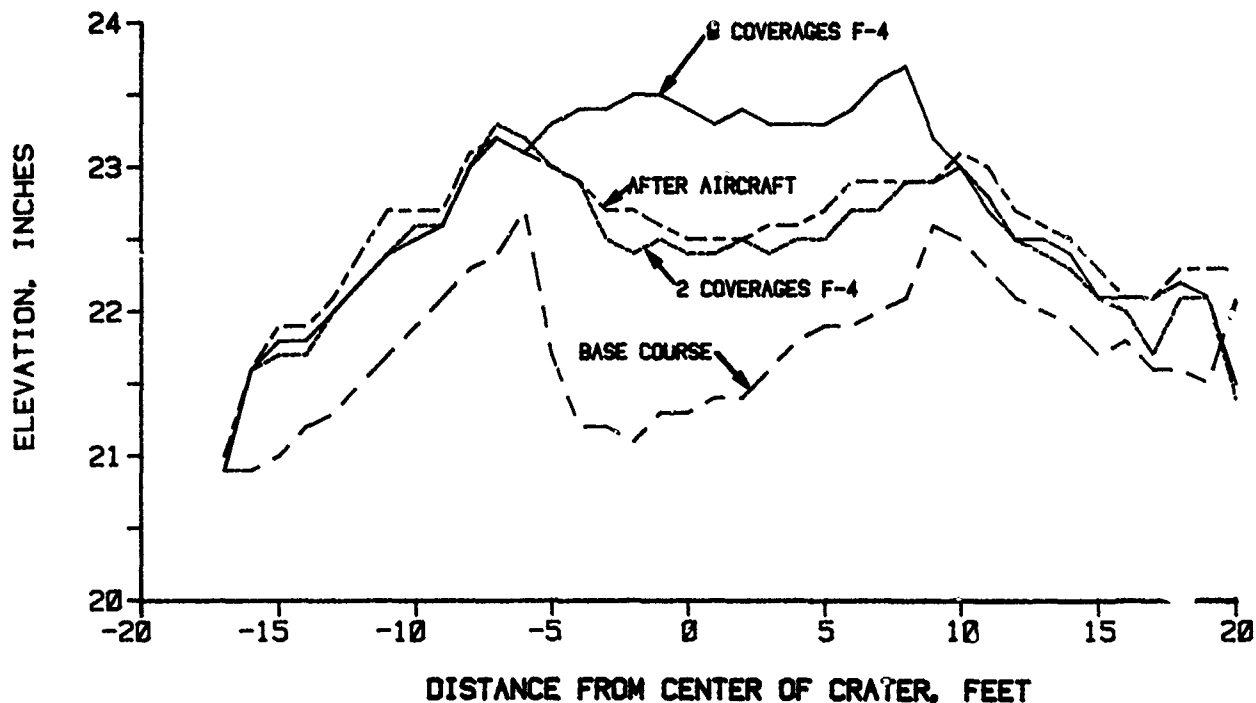
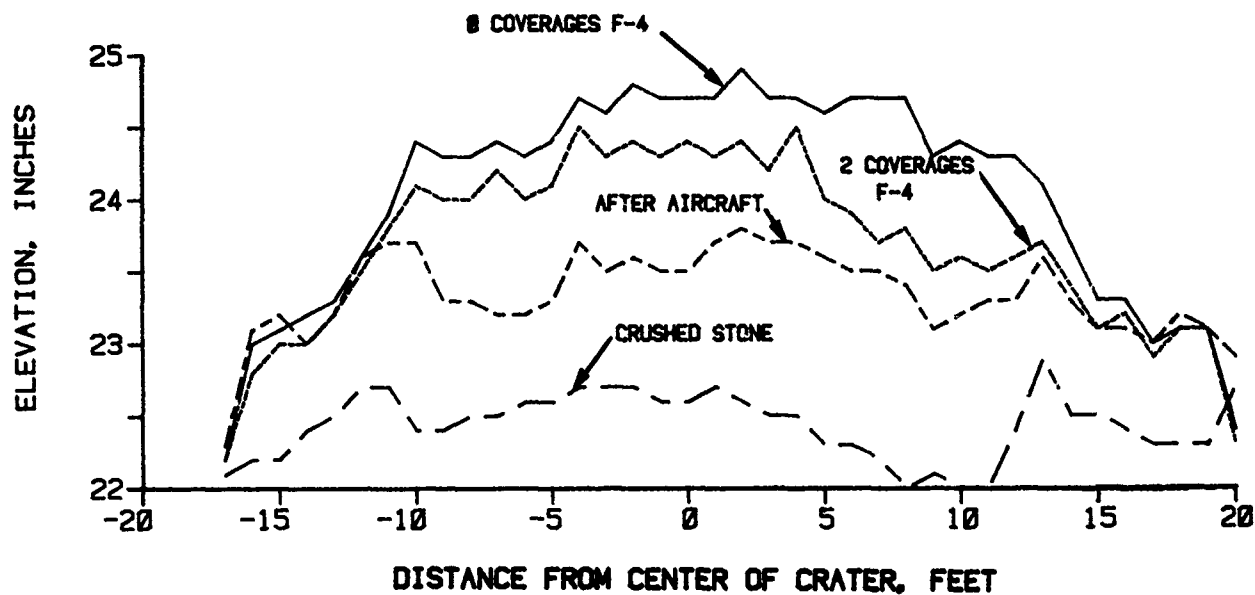
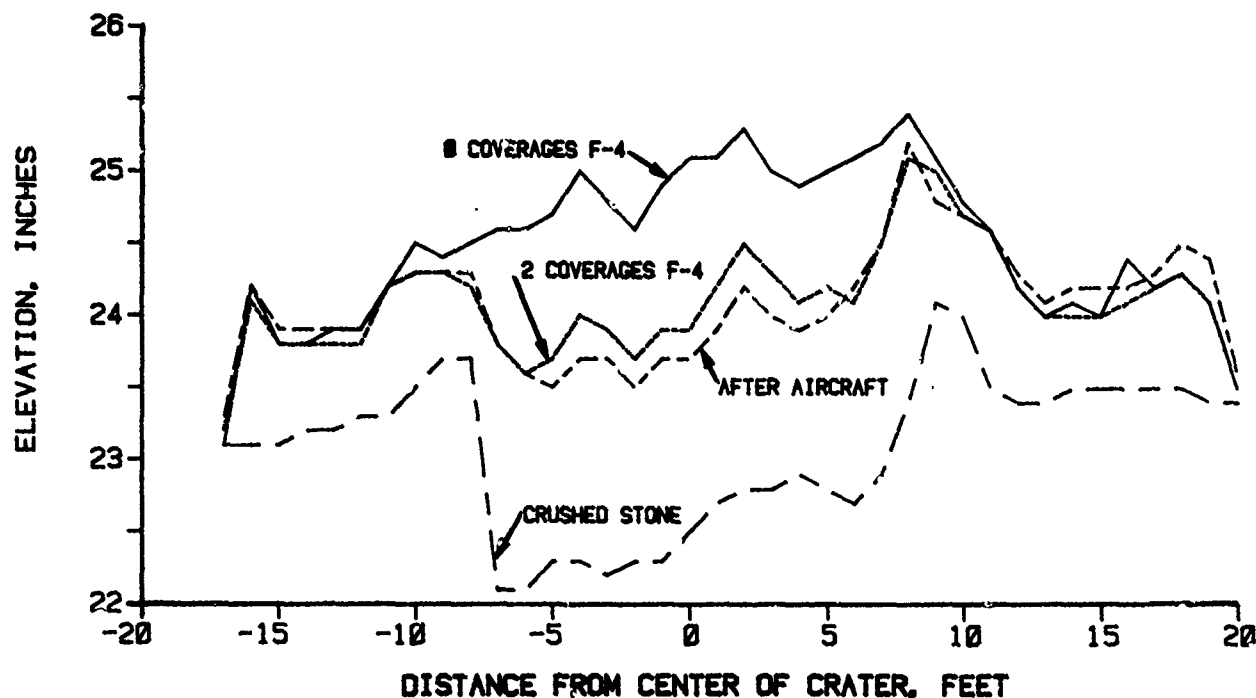
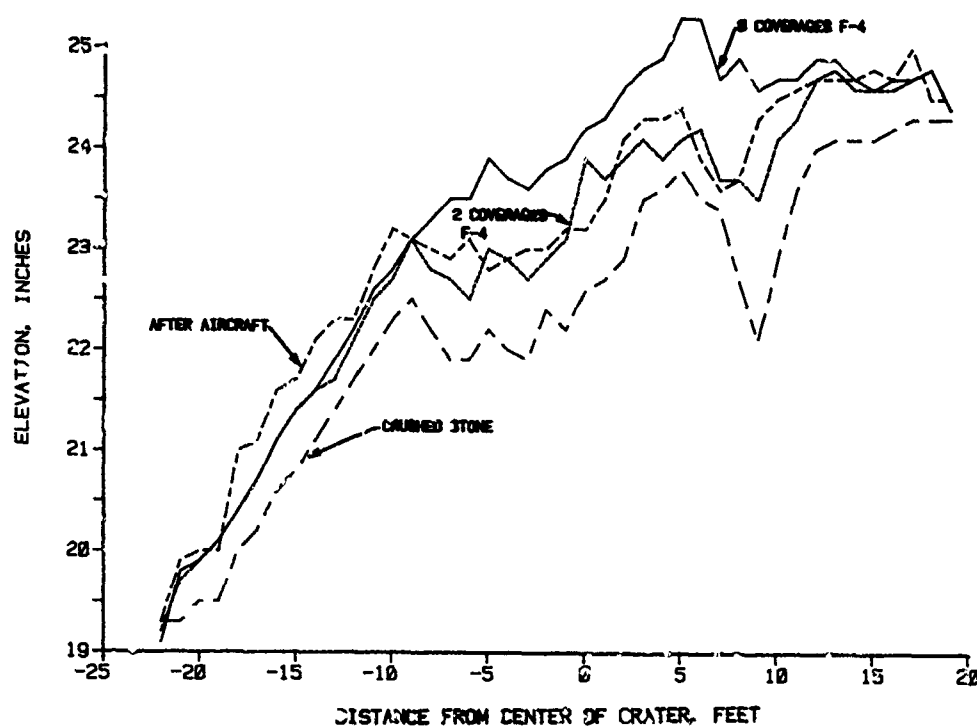
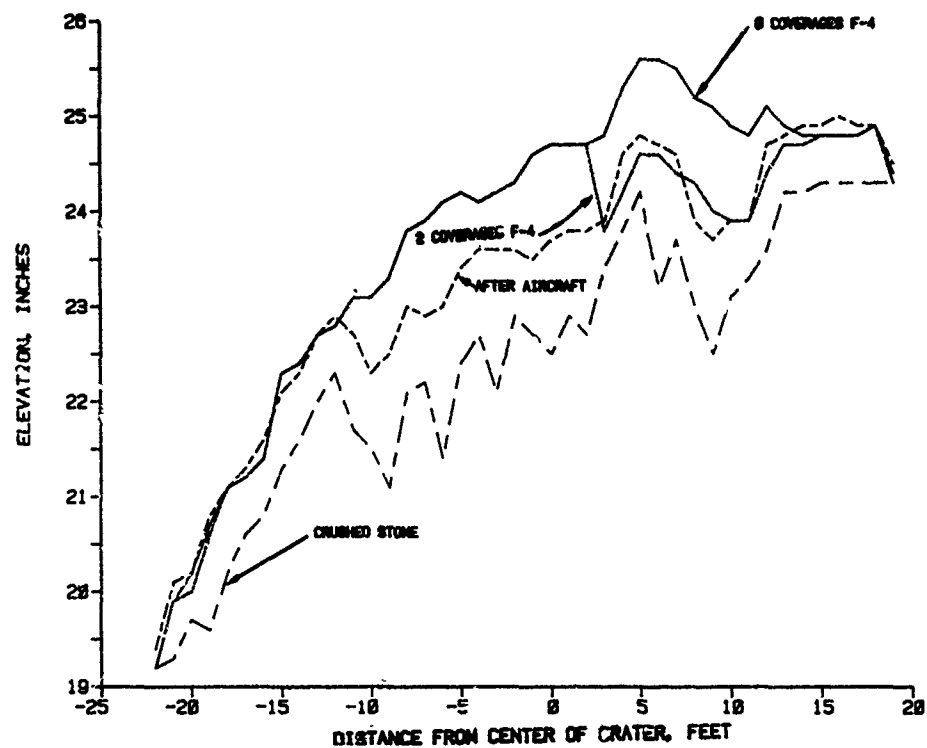
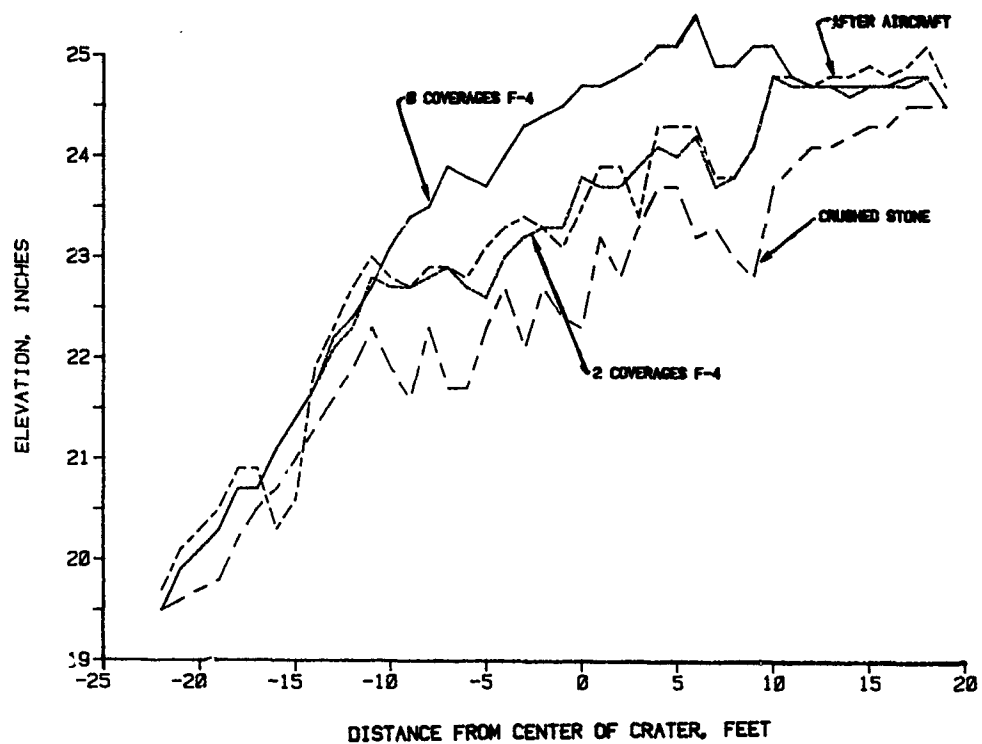
Figure 67. North wheel path profile, FOD cover repair, 0 coverages, 2 coverages of F-4 load cart, and after F-4 aircraft traffic

wheel was located inside the actual crater. The bow wave was first observed when the load wheel first traversed the south side of the crater and continued until the load wheel had moved approximately 4 ft inside the crater (after about five passes). A bow wave was not observed as proof rolling continued across the remaining 21-ft crater width. After proof loading, two tears were observed in the top ply of the FOD cover. A 10-in. tear (Photo 41) was located 2 ft east of the center of the crater on the crater east-west center line and the other, a 15-in. tear, was located on the third FOD cover hinge from the south edge of the FOD cover (Figure 66). The FOD cover had numerous small ridges or wrinkles (manufacturing defects), most of which contained hairline cracks after the proof loading. Surface roughness measurements without a load show a 1.0- to 2.75-in. upheaval with zero sag after proof loading (two coverages, F-4 load cart); however, loaded measurements using the load wheel on the F-4 load cart show no upheaval and sag measurements that range from 0.8 to 1.2 in. (Table 6). This would indicate that underlying fill material was consolidated during proof loading which resulted in a 0.8- to 1.2-in. void between FOD cover and the fill material. Cross-section plots after two coverages of the F-4 load cart (proof loading) are shown in Figures 67 through 72.

cover (Photo 42). The loose fiberglass landed approximately 165 ft behind the crater repair. The performance of the FOD cover repair was not affected by the 20- by 74-in. damaged area. After the touch-and-go operations, light and heavy braking runs and a sharp turn maneuver by the aircraft were made on the FOD cover. No additional distress to the FOD cover was observed during these operations. Photo 43 is a general view of the FOD cover repair after the aircraft test runs. Figures 67 through 72 show profile and cross-section plots of the crater repair after aircraft traffic.

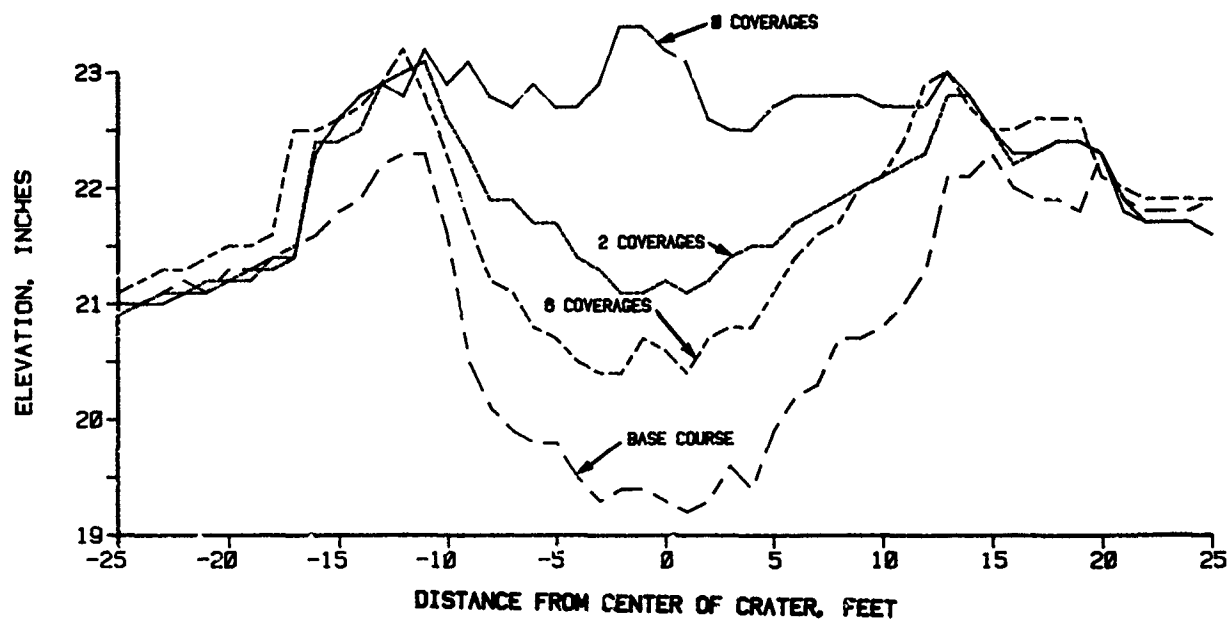
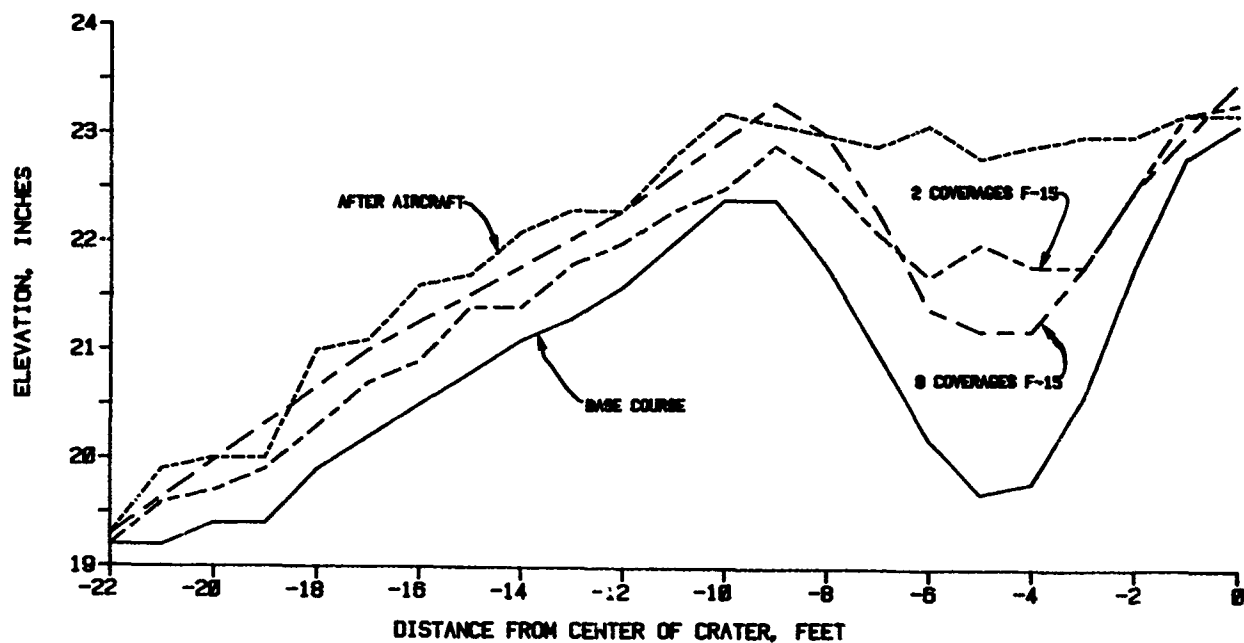
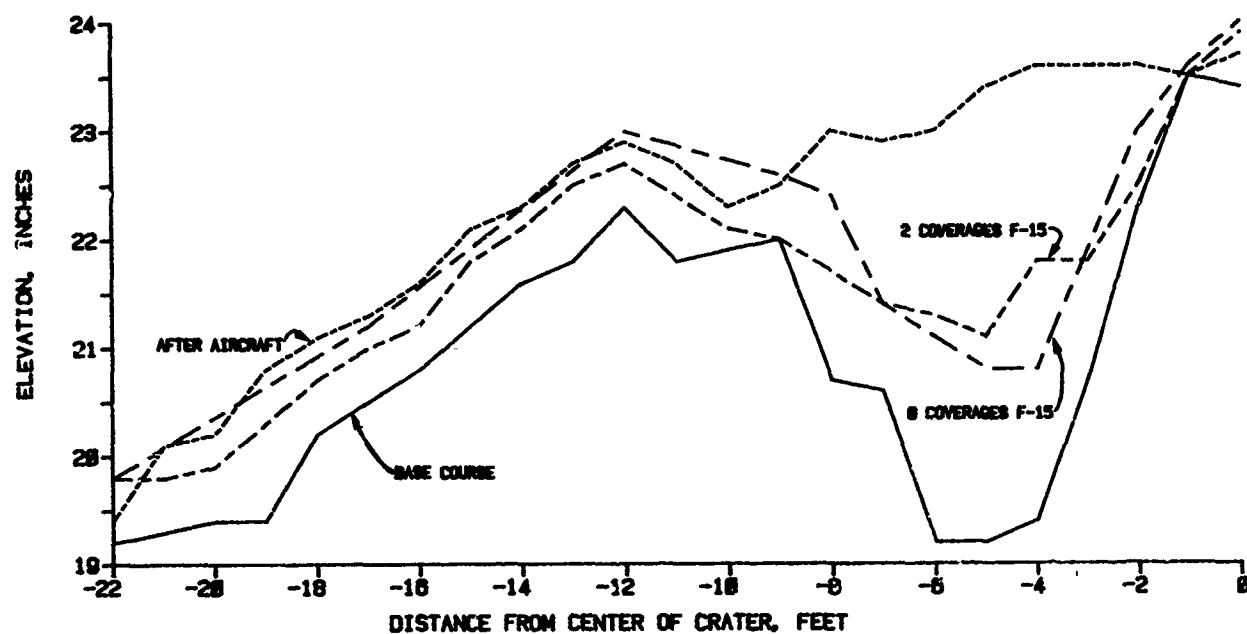
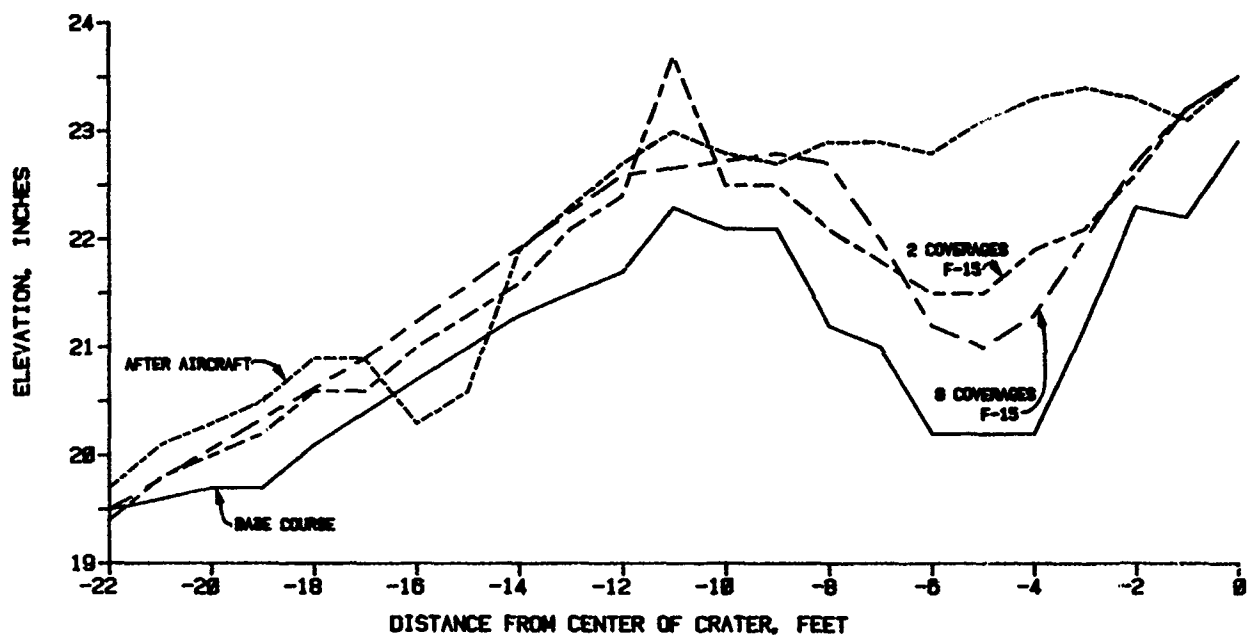
Figure 73. Profile, center of the F-15 traffic lane, FOD cover repair, 0 coverages, 2 coverages, and 6 coverages

lane at this time. None of these additional tears was located on a hinge and they ranged in length from 1 to 4 ft. Four of these tears were in the top ply and one tear, 1 ft long, was through both plies. Figures 73 through 76 show profile and cross-section data on the FOD cover and base course (FOD cover removed) for the traffic lane after six coverages.
